Scientific Conservation of Wooden Altars of Goa Churches – A Case Study

S. Vinodh Kumar¹, M. Singh^{2*} & Nilesh E Mahajan¹

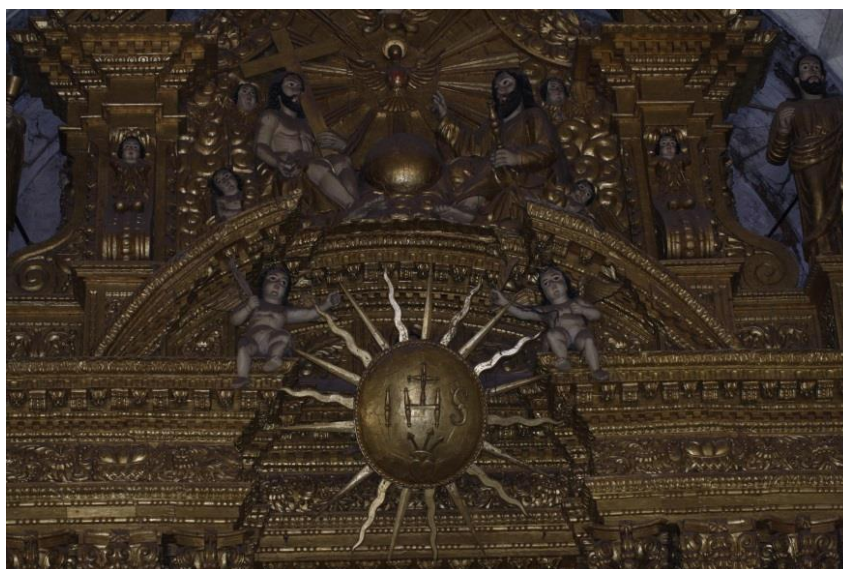
The conservation issues further noticed in the polychromed wooden altarpieces are deposition of thick coat of dust and dirt as the wooden altars were not cleaned for the last five decades (Figure 3). Insect activity was also noticed in some parts of the altars especially in the lower panels where St. Xavier's relic is being kept (Figure 4a and b). Powdering of wood and some of the alters had small voids, pits, and having insect activity. In many portions in the lower levels of altars there were holes, lacunas; cracks are noticed by the result of termites.

Figure 3. Deposition of accretions over the altars of Basaliica of Bom Jesus Church, Old Goa

First up all, huge scaffolding was erected for execution of scientific conservation of polychrome wooden altars as they are huge in sizes. Then the general dusting was carried out using soft brushes and with the help of low pressure vacuum cleaners. Further, the accretions were cleaned with cotton absorbent using the mixture ethanol, iso-propyl alcohol with few drops of distilled water with non-ionic detergent. Here, few drops of water was used in the solution to make the soap solution effective. Finally, 2% Polyvinyl acetate (PVA) was applied as preservative coat. Figures 7-13 are showing the condition of wooden altars before and after scientific conservation.

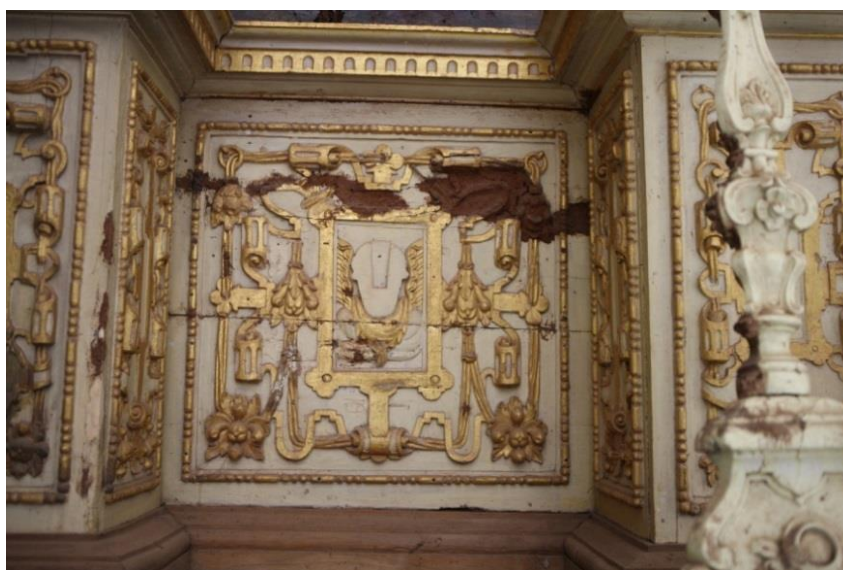
Figure 4a. Deterioration of Wooden altars of Goa Churches due to insect activity

The wooden altars were also found damaged in some portions and the same were consolidated and the mending works in some places were also attended. The wooden altars around the St. Francis relics were severely affected by dry termite especially at lower parts that has almost been eaten away by termites. In many portions in the lower levels of altars there are holes, lacunas; cracks are noticed by the result of termites. The consolidation of wooden altars had already been carried out as follows. First, the entire wooden altar especially the damaged portions are being injected with 'Termiseal' and then the lacunas are being filled with the mixture of saw dust, wood putty, Araldite carpenter. Then the area was allowed it for complete drying. Then the portions were matched with the surrounding colours. The anti-termite treatment of all the church complexes was also carried out in the step of preventive conservation.

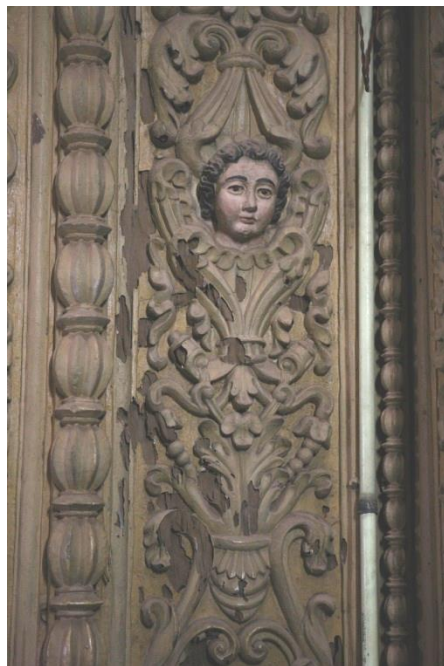
Figure 4b. Deterioration of Wooden altars of Goa Churches due to insect activity

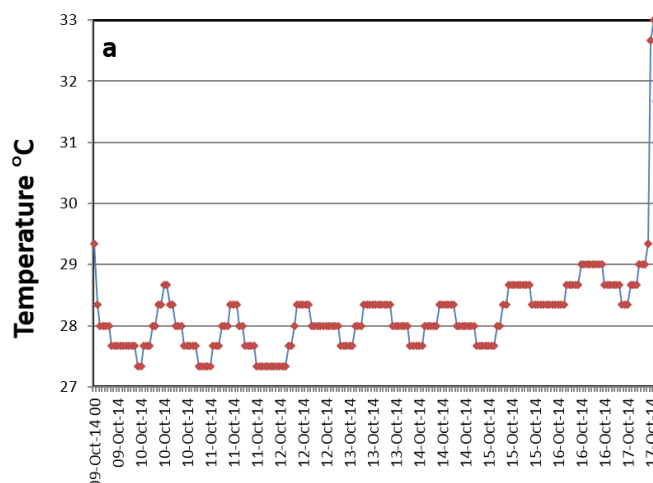
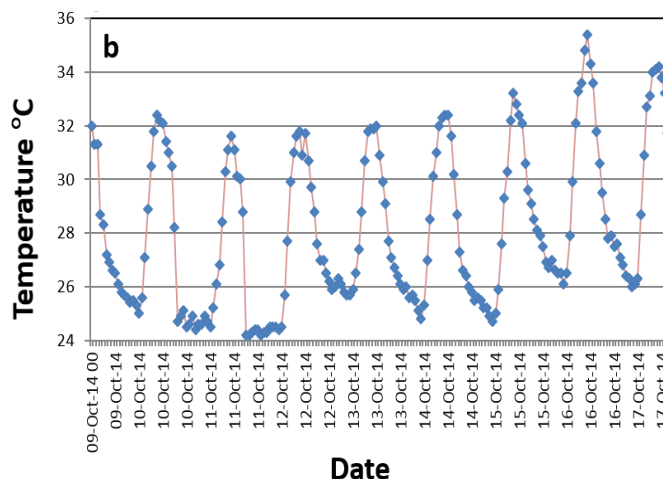
Archaeological Survey of India has installed an automatic weather station in front of Se' Cathedral church in collaboration with Indian Space Research Organization (ISRO, Bangalore). This station records the surrounding temperature, relative humidity, wind speed, wind direction, rain fall and radiations at regular intervals. For monitoring microclimatic conditions inside the Church, an automatic Temp/RH data logger (Make: Oakton) was inside the Church. The temperature recorded inside Bom Jesus Church and outside the church is shown in Figure 5. From the graph it can be seen that the temperature range inside is 27°C to 29°C, which is almost 2 to 3°C lesser that of the outside temperature. The temperature may not be affecting the polychrome wooden altarpieces. The reason for the difference in inside and outside temperature is may be the architecture of the churches.

Figure 5. Temperature data recorded -

Inside (a) and outside (b) of Basilica of Bom Jesus, Church, Old Goa

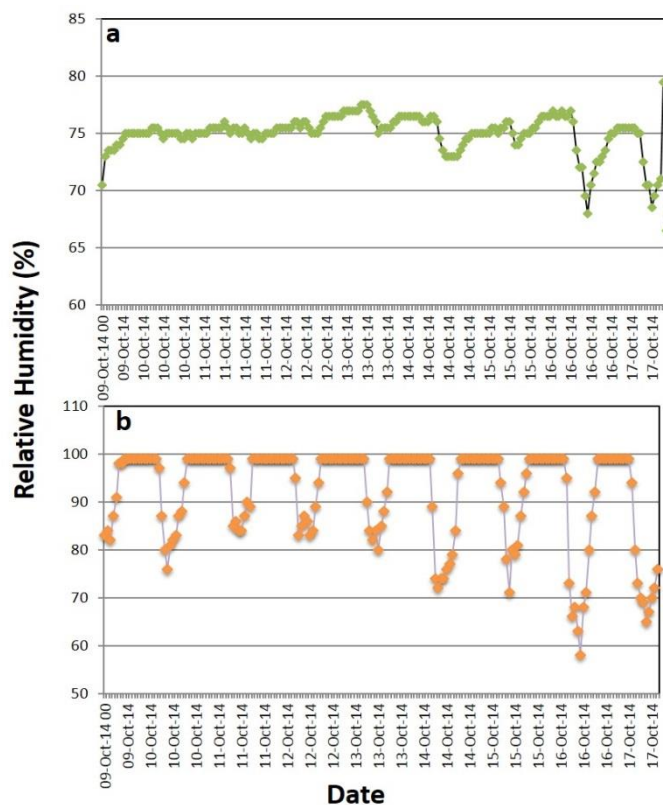
Figure 6 shows the relative humidity (RH) recorded inside Bom Jesus Church and outside the church respectively. The humidity recorded outside the church is in the range of 80 to 100% whereas inside in the range of 70 to 80%. The difference in inside and outside humidity is due to the architecture of the church by laterite stone blocks. Still, the inside relative humidity is so high that of the recommended value of 50 – 55 %. The high humidity may be one of the factors for the deterioration of the wooden altarpieces. Huge number of tourists and devotees visits the Churches every day along with dust in their shoes is also one of the reasons for deposition of dust and dirt on the polychrome wooden altarpieces.

Figure 6. Relative humidity (RH) data recorded -

Inside (a) and outside (b) of Basilica of Bom Jesus, Church, Old Goa

Some of the windows and the doors of the Church are permanently closed. So, it is recommended to fit exhaustor fans in the three windows of the walls to control the humidity. All three main doors of west side have to be opened during day time for air flow. These are some measures to control the relative humidity level inside the church.

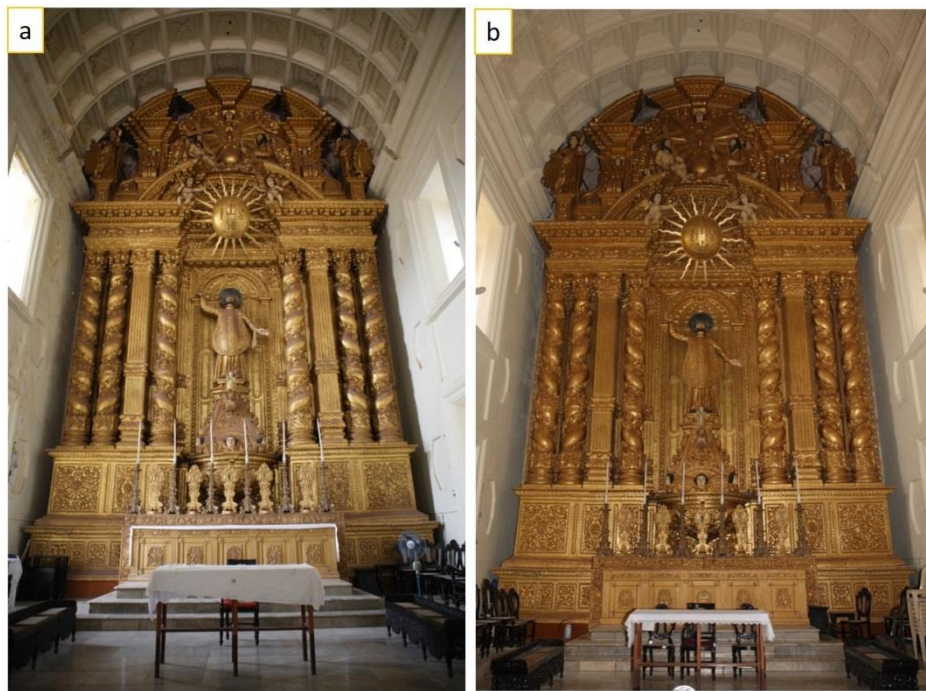
Figure 7. Main altar, Basallica of Bom Jesus Church, Before (a) and after (b) scientific conservation

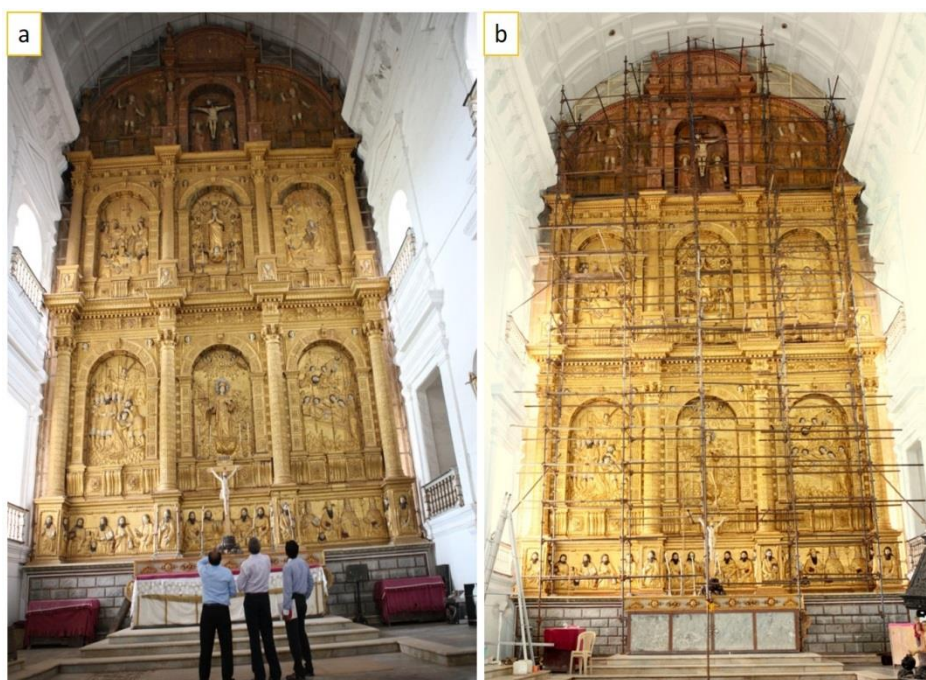
Figure 8. Main altar, Se' Cathedral Church, Before (a) and after (b) scientific conservation

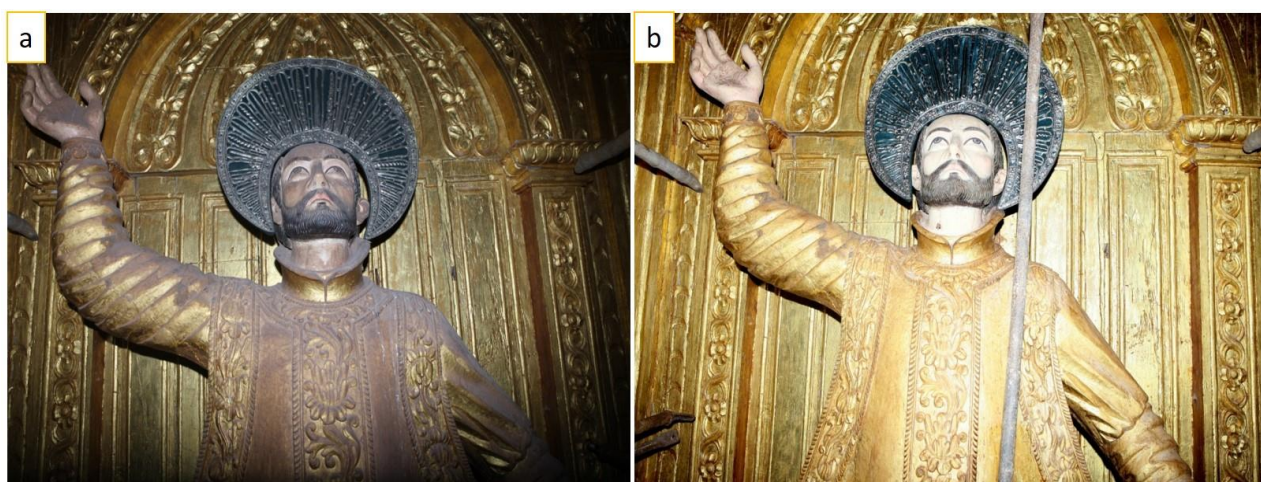
Figure 9. Polychrome Sculptures, Main altar, Basallica of Bom Jesus Church -
Before (a) and after (b) scientific conservation

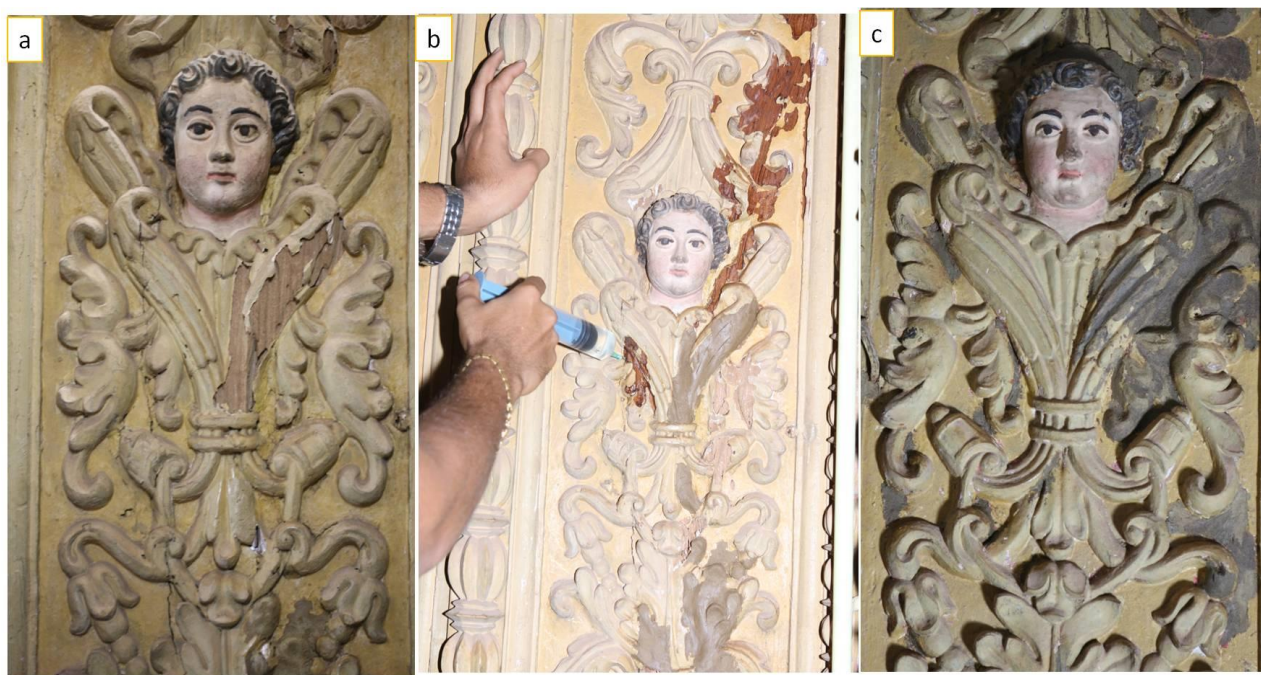
Figure 10. Polychrome altar, Basallica of Bom Jesus Church, Before (a), (b) during anti-termite treatment, and
after (c) mending and consolidation work

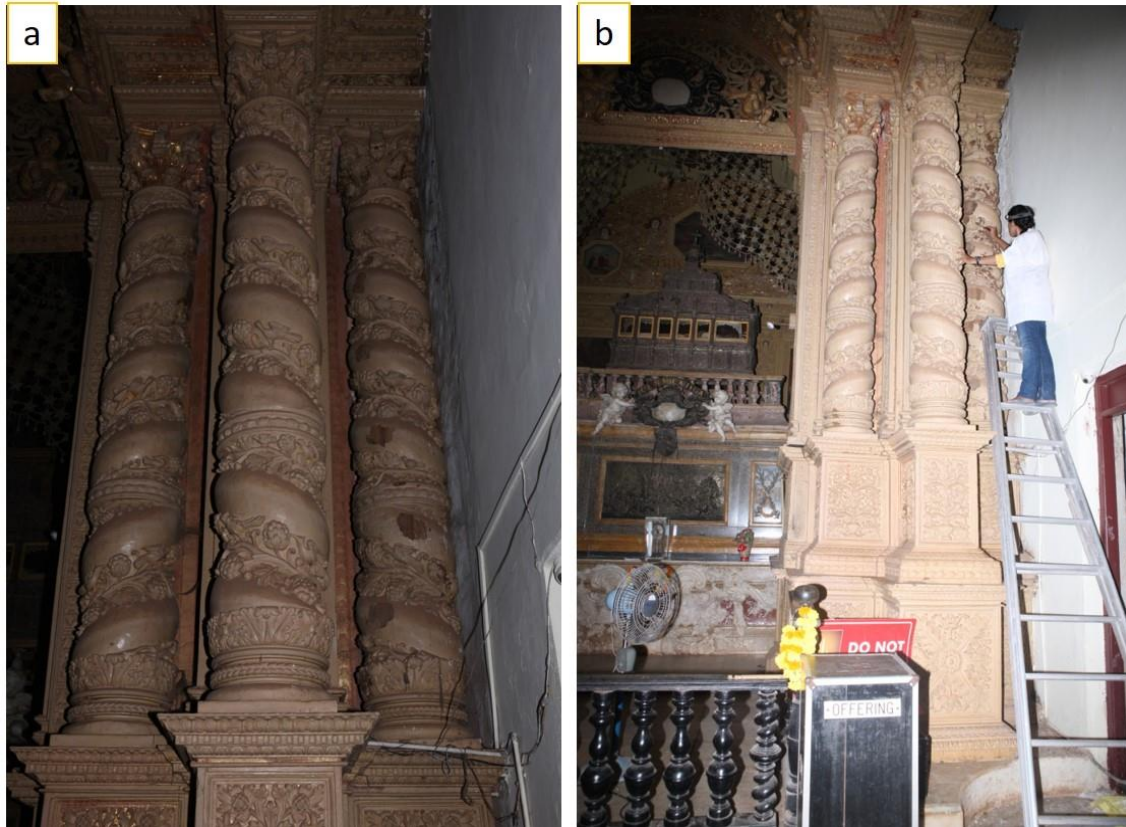
Figure 11. Polychrome altar, Basallica of Bom Jesus Church,
Before (a) and after (b) mending and consolidation work

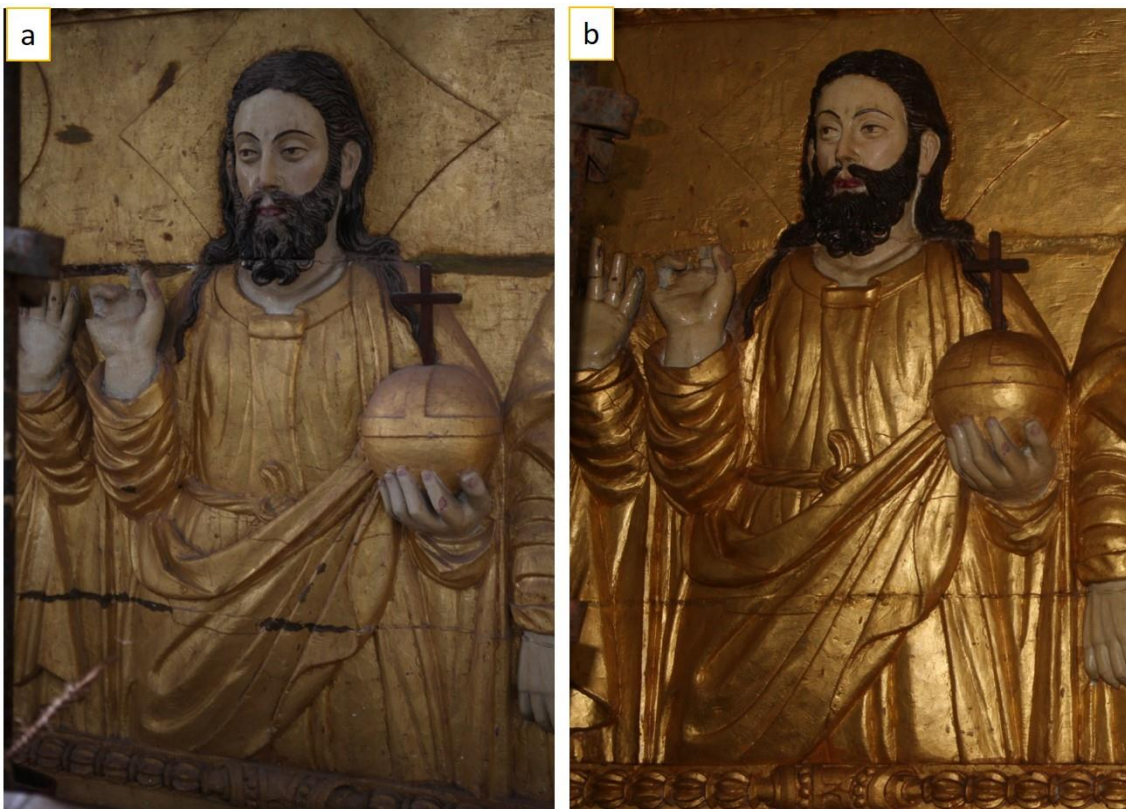
Figure 12. Polychrome Sculptures, Main altar, Se' Cathedral Church,
Before (a) and after (b) scientific conservation

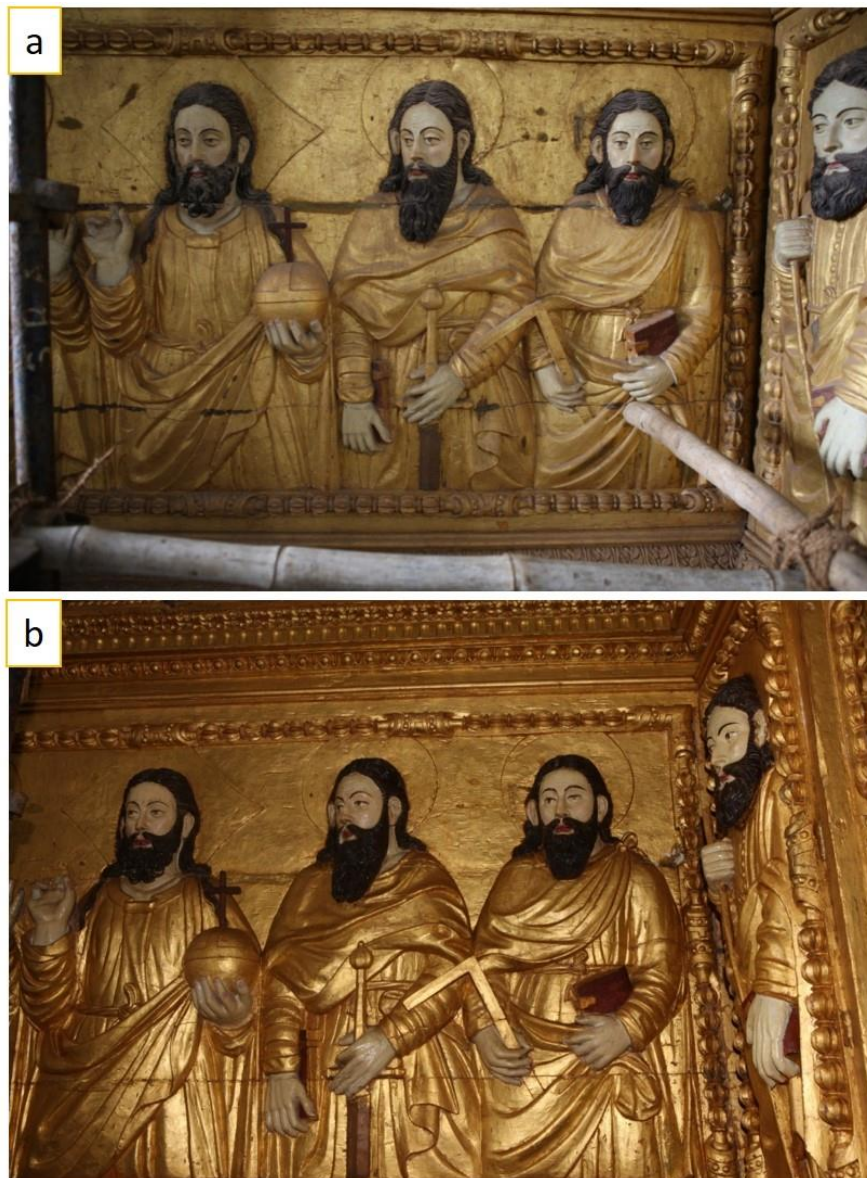
Figure 13. Polychrome sculptures, Main altar, Se' Cathedral Church,
Before (a) and after (b) scientific conservation
